**Coal Combustion Waste Impoundment  
Round 7 - Dam Assessment Report**

*Sioux Power Station*

*Ameren Missouri*  
**St. Charles County, Missouri**

**December 2011**

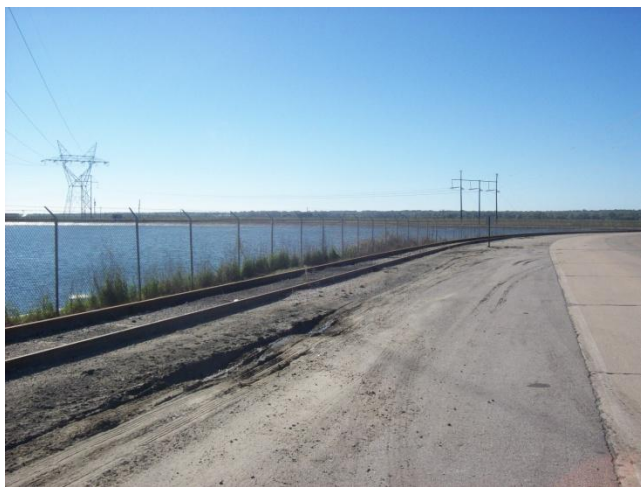
The crest of the embankment had no signs of significant depressions, tension cracks, or other indications of settlement or shear failure. Figure 5.2.1-1 shows the crest along its western boundary. The railroad and access road to the plant form the embankment. In this area the embankment is quite wide, approximately 75 feet in width.

Figure 5.2.1-1: Photograph of Fly Ash Embankment, View to the South

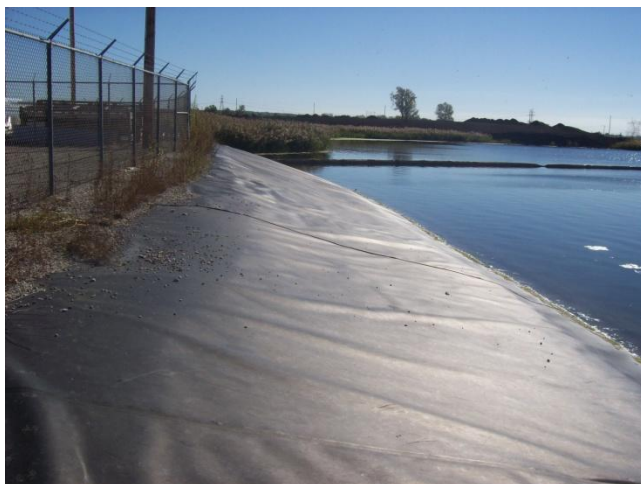
According to the Reitz & Jens, Inc. 2007 Phase I Sioux Plant Report provided by Ameren Missouri, the Fly Ash Pond was lined with a 60-mils thick HDPE liner in 1993. There were no observed scarps, sloughs, bulging, cracks, depressions or other indications of slope stability problems. Figure 5.2.2-1 shows a representative section of the upstream/inside slope of the embankment.

Figure 5.2.2-1: Photograph of Upstream/Inside Slope of Fly Ash Pond, View Looking East

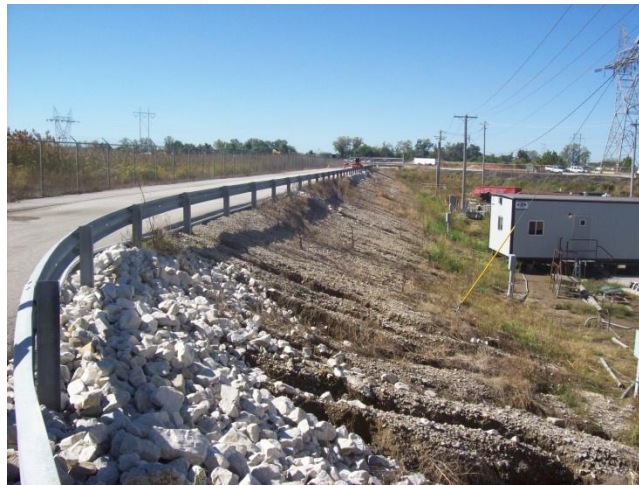
Areas of surface runoff erosion were observed on the downstream/outside slope of the Fly Ash embankment in parts. Rip-rap has been added to those areas to minimize future erosion and they are monitored for stability on a weekly basis. Figure 5.2.3-1 shows one example of the eroded areas at the time of the site visit, near the northwest corner of the embankment. The area shown in Figure 5.2.3-1 has been regarded and repaired, in January 2011, utilizing geotextile and riprap for the the entire length of the face of the embankment slope to minimize future erosion.

Figure 5.2.3-1: Photograph of Fly Ash Dam Downstream/Outside Slope, View to the South

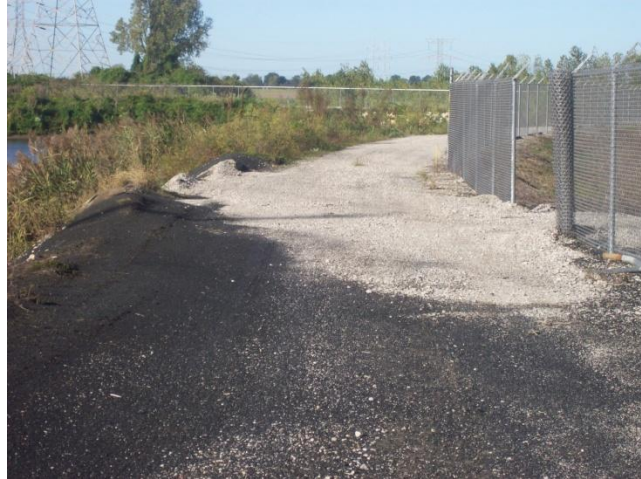
The crest of the embankment had no signs of significant depressions, tension cracks, or other indications of settlement or failure. There were some areas of erosion which have been overlain with rip-rap to enhance stability. One area of the embankment had obvious signs of ash along the inside slope and crest (Fig. 5.3.1-1).

Figure 5.3.1-1: Photograph of Bottom Ash Pond with ash on crest, View Looking West

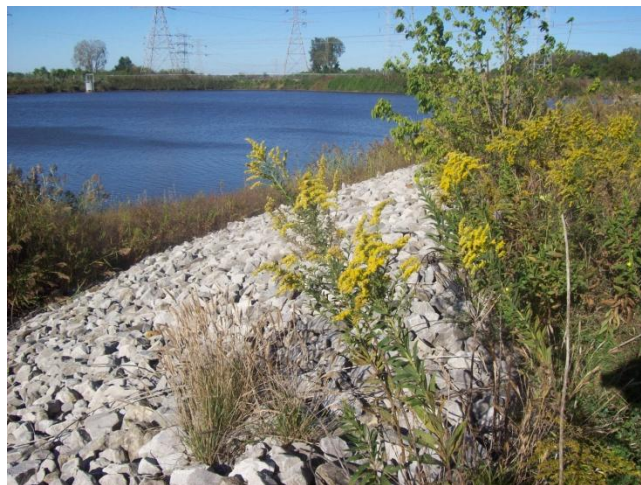
The upstream/inside slope is vegetated with various scrub/shrub species and tall grasses and wildflowers. There were no observed scarps, sloughs, bulging, cracks, depressions, or other signs of slope instability. Rip-rap had been placed along the interior slopes of the northern and northwestern portions of the embankment to enhance stability.

Figure 5.3.2-1: Photograph of Bottom Ash Pond Upstream/Inside Slope, View Looking West

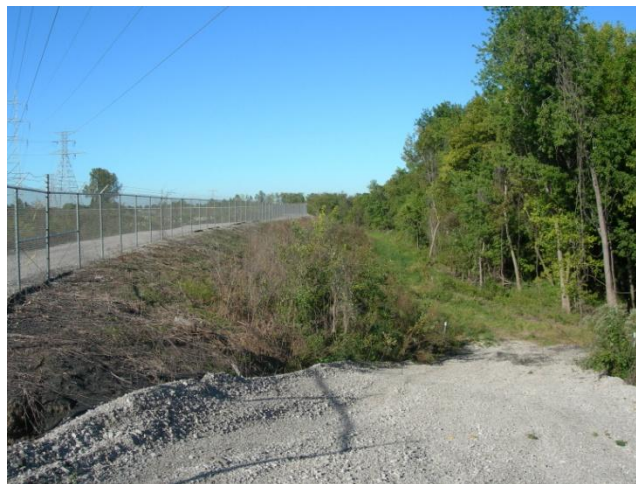
The downstream/outside slope and toe of the Bottom Ash Pond embankment are covered in various plant species; along the slope are various scrub/shrub plant species and tall grasses and wildflowers, while some larger trees are located at the toe of the slope.

Figure 5.3.3-1: Photograph of Bottom Ash Pond Downstream/Outside Embankment, View Looking North

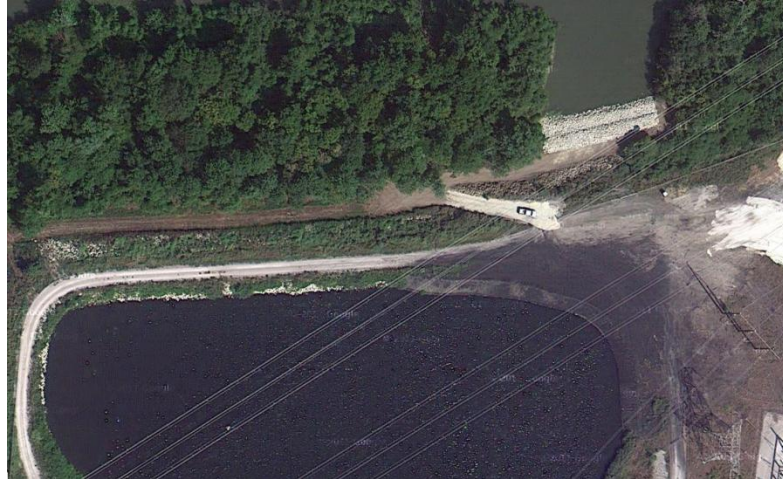
However, study results showed the Bottom Ash Pond dam did not meet the minimum required Factor of Safety for Full Reservoir, Steady Seepage loading. The rating was 1.4 which is below the 1.5 minimum. This point of concern was attributed to the west side of the Bottom Ash Pond. As noted in the 2010 report, there is seepage from one concentrated area along the west embankment. Ameren began monitoring this location on a weekly basis. Reitz & Jens, Inc. in the 2010 stability report (Appendix A – Doc 06) recommended a project to improve the west dike such that the Bottom Ash Pond could meet minimum factors of safety.

The Bottom Ash Pond factor of safety recommendations and computations from Reitz & Jens, Inc. are shown in Document 7 in Appendix A. Figure 7.1.4-1 shows remediation activities that addressed the safety factor issues. The additional of an inverted filter and rip-rap along the outside of the embankment is part of the proposed safety factor improvement project.

Figure 7.1.4-1: Bottom Ash Pond embankment safety factor improvements underway.

In 2011 Ameren Missouri carried out the recommendations from the 2010 report. In September 2011, the utility completed installation of an inverted filter along the seepage area and provided new calculations of static loading slope stability (see Appendix A – Doc 07). The slope stability analysis shows that there is an Acceptable Factor of Safety of 1.64 under static conditions using the new configuration. The Bottom Ash Pond dam rating is therefore changed to **SATISFACTORY**.

It is recommended that Ameren Missouri monitor the west side dike of the Bottom Ash Pond for at least a year to ensure seepage has stopped following completion of the dike improvements.

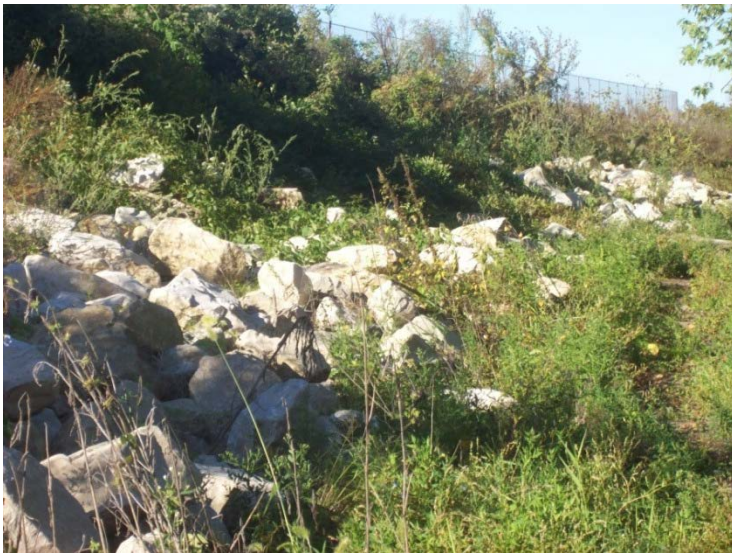
A small seep was observed (Fig. 5.3.3-2) in the northeastern corner of the pond embankment, approximately 75' from the toe of the embankment. The situation is monitored weekly by Ameren Missouri personnel.

**11. Seep location approximately 75' from toe of embankment and flows to the Mississippi River. Note – seep water is clear and being monitored by weekly inspection team.**

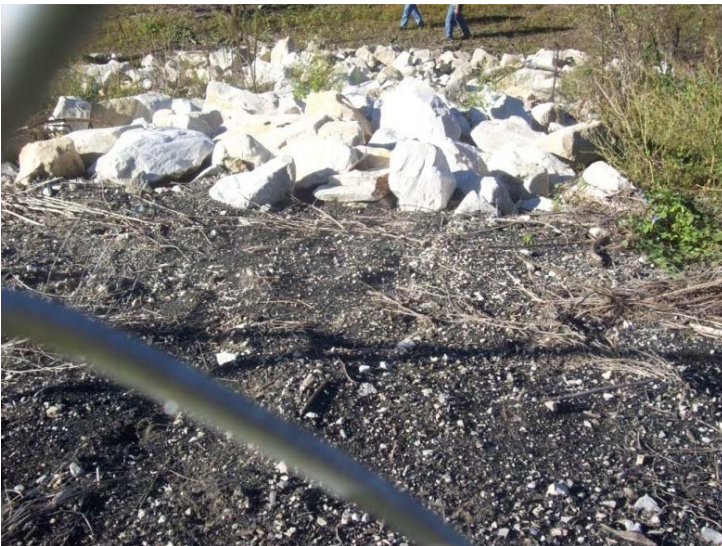
**31. Repair of eroded area lined with riprap.**

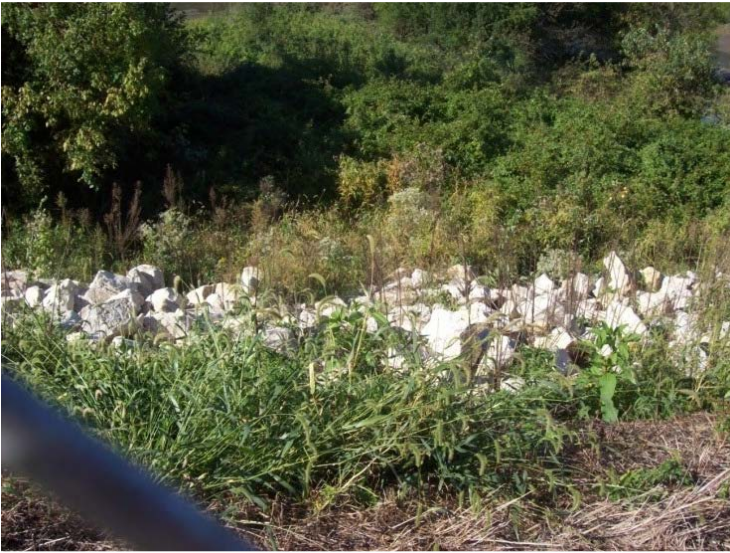
**32. Exterior slope along Southwest side lined with riprap.**

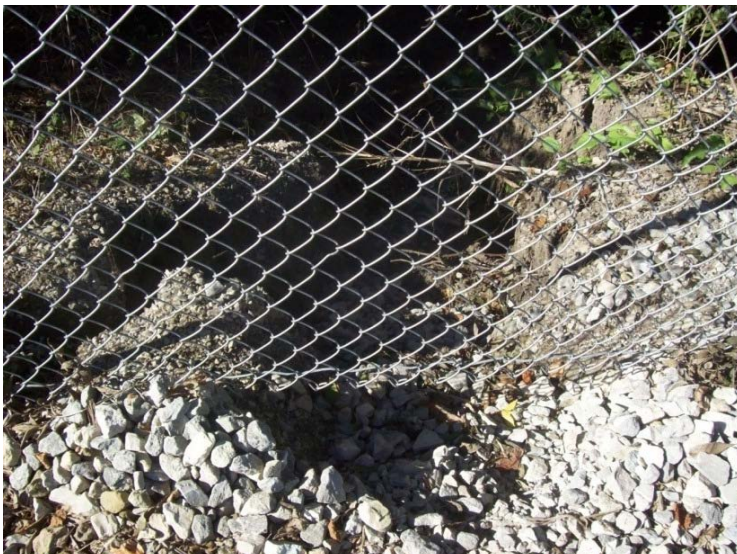
**35. Erosion area caused by surface runoff.**

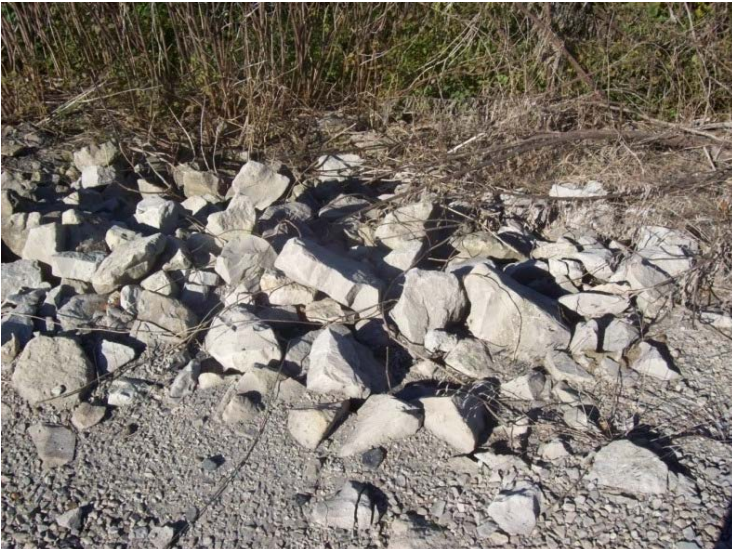
**49. Looking at riprap that is used to repair surface runoff erosion.**

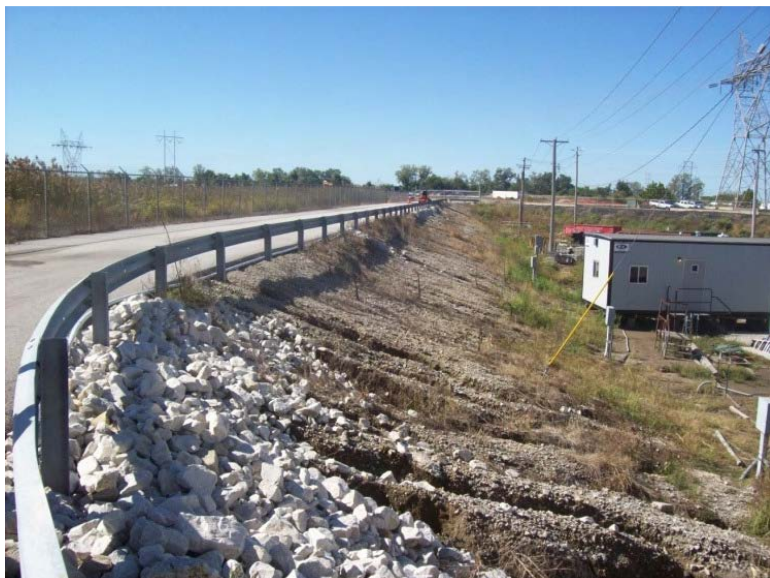
**70. Looking along embankment and repair measures addressing runoff erosion.**

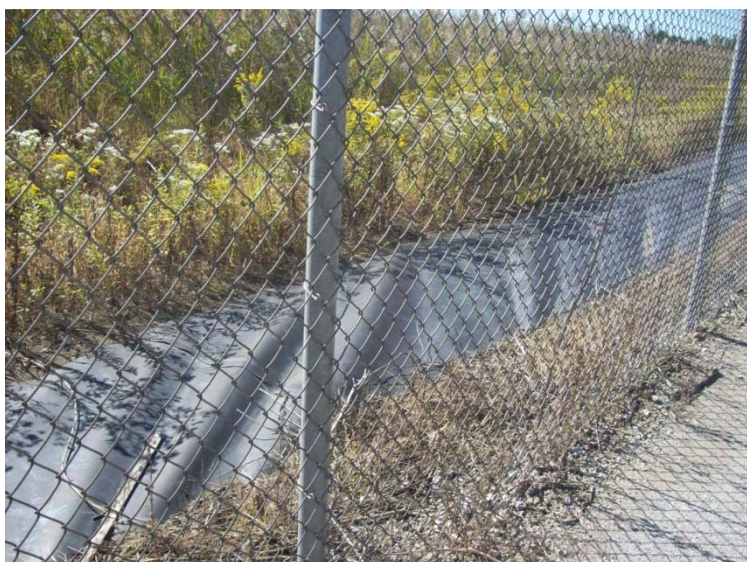
**71. Looking at pond embankment and liner. Note - fill material (Fly Ash) over liner.**
